**MOBILE TREE COMMISSION
STAFF REPORT****Date: June 19, 2018**

<u>APPLICANT NAME</u>	Alabama Benin Trade & Cooperative Forum / Dr. Sharon Ingram
<u>LOCATION</u>	3809 Moffett Road (South side of Moffett Road, 715 ± feet east of Moffett Court)
<u>REQUEST</u>	Removal of large oak in the right-of-way along Moffett Road
<u>CITY COUNCIL DISTRICT</u>	District 7
<u>PRESENT ZONING</u>	B-1, Buffer Business District
<u>HEALTH OF TREE</u>	Some die-back is occurring, there is damage at the base of the trunk, and bracket fungi is present on living branches
<u>CONTRIBUTING FACTORS</u>	N/A
<u>ENGINEERING COMMENTS</u>	None
<u>TRAFFIC ENGINEERING COMMENTS</u>	None
<u>URBAN FORESTRY COMMENTS</u>	No comments received.
<u>PLANNING COMMENTS</u>	None.
<u>MAWSS</u>	N/A
<u>ANALYSIS</u>	The applicant is requesting removal of a large live oak in the right-of-way along Moffett Road. The tree appears on a 1971 survey prepared by the Alabama Department of Transportation (ALDOT) as a 36-inch oak. The tree was not measured by staff during a site visit, but it appears to have a trunk approximately 60 inches in diameter, with a canopy spread of approximately 80 feet.

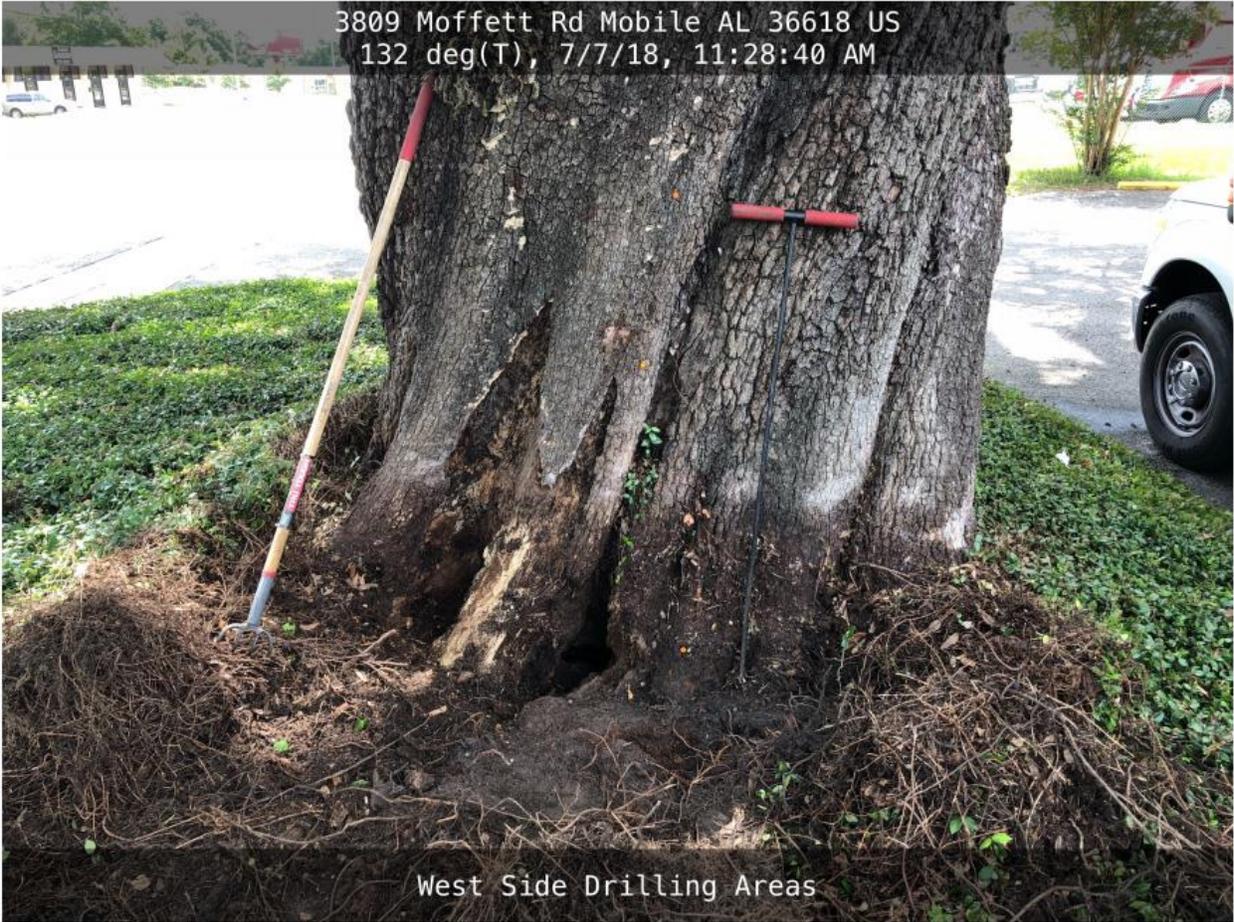
West Side Drilling Areas

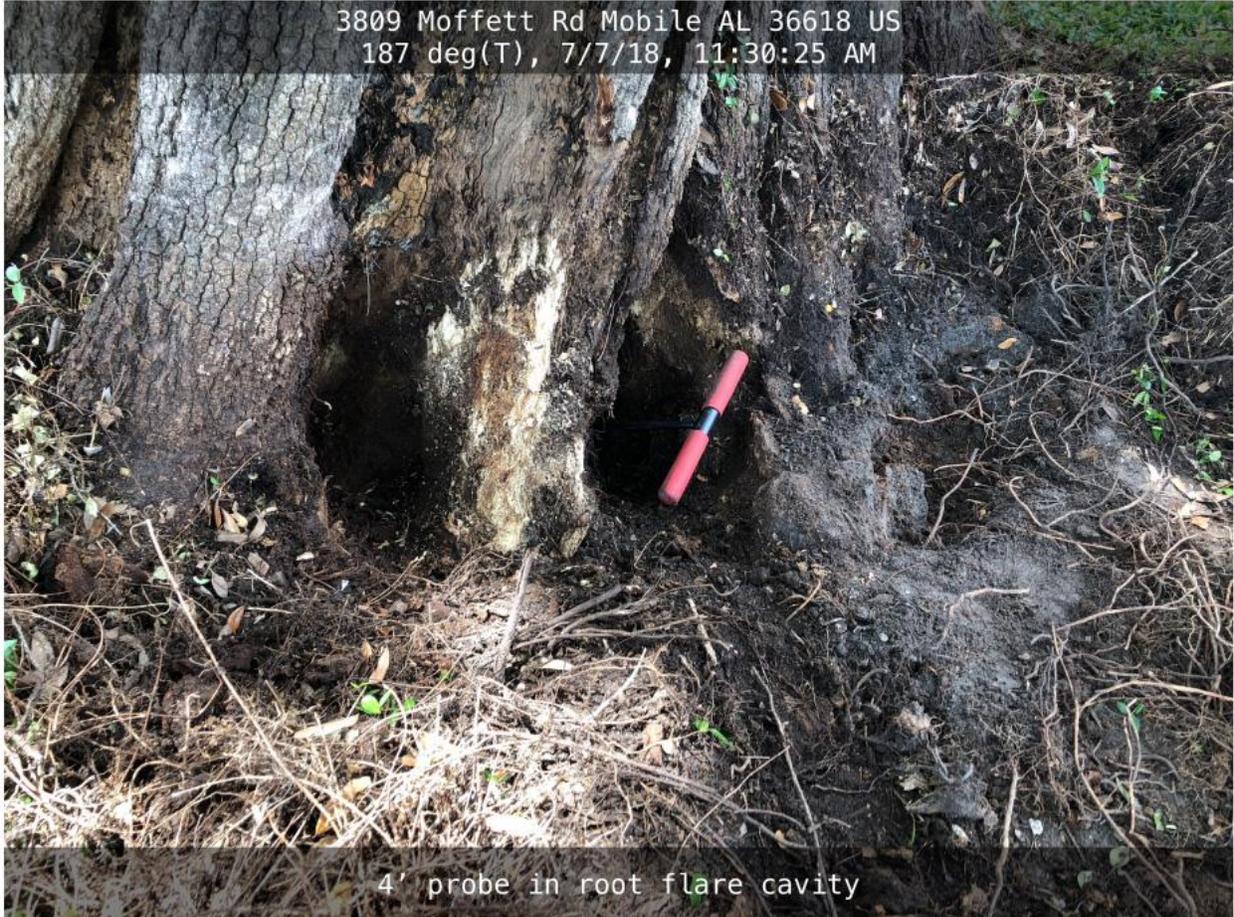
The decision for mitigation and timing of prescribed treatments depends on the risk tolerance of the City of Mobile. Residual risk is the risk remaining after the corrective actions are completed. If the decision is made to retain the tree and do mitigation measures described below, the residual risk rating of this tree part would be reduced to Low rating. The risk rating for the canopy of the tree has decreased because of the dead branches and scaffolds will have been pruned from the tree. I do not recommend this course of action because the amount of canopy that would need to be removed from the tree. This amount of pruning would drastically impact the tree’s ability to perform photosynthesis. Without the proper amount of nutrients from photosynthesis combined with other stress factors, the tree would go into a severe state of decline. There are no ways to mitigate the issues of the decay in the root plate and at the cavity at the base of the trunk.

- *My recommendation is for removal of the Live Oak based on the characteristics of the wood decay fungus combined with the overall decline in the canopy. Both of these factors lead me to believe that the root plate has significant loss. Testing the strength of the root plate is not available or very accurate, other visual factors are taken into consideration when determining the amount of root loss. There are several visible signs throughout the canopy that leads me to believe that the root plate has lost several structural roots as described in the findings. Trees with decaying root plates are more likely to fail during significant weather conditions, as root plates are in part the structural anchor points for the tree.*

4' probe in root flare cavity
