**MOBILE TREE COMMISSION
STAFF REPORT****Date: June 19, 2018**

<u>APPLICANT NAME</u>	Alabama Benin Trade & Cooperative Forum / Dr. Sharon Ingram
<u>LOCATION</u>	3809 Moffett Road (South side of Moffett Road, 715 ± feet east of Moffett Court)
<u>REQUEST</u>	Removal of large oak in the right-of-way along Moffett Road
<u>CITY COUNCIL DISTRICT</u>	District 7
<u>PRESENT ZONING</u>	B-1, Buffer Business District
<u>HEALTH OF TREE</u>	Some die-back is occurring, there is damage at the base of the trunk, and bracket fungi is present on living branches
<u>CONTRIBUTING FACTORS</u>	N/A
<u>ENGINEERING COMMENTS</u>	None
<u>TRAFFIC ENGINEERING COMMENTS</u>	None
<u>URBAN FORESTRY COMMENTS</u>	No comments received.
<u>PLANNING COMMENTS</u>	None.
<u>MAWSS</u>	N/A
<u>ANALYSIS</u>	The applicant is requesting removal of a large live oak in the right-of-way along Moffett Road. The tree appears on a 1971 survey prepared by the Alabama Department of Transportation (ALDOT) as a 36-inch oak. The tree was not measured by staff during a site visit, but it appears to have a trunk approximately 60 inches in diameter, with a canopy spread of approximately 80 feet.

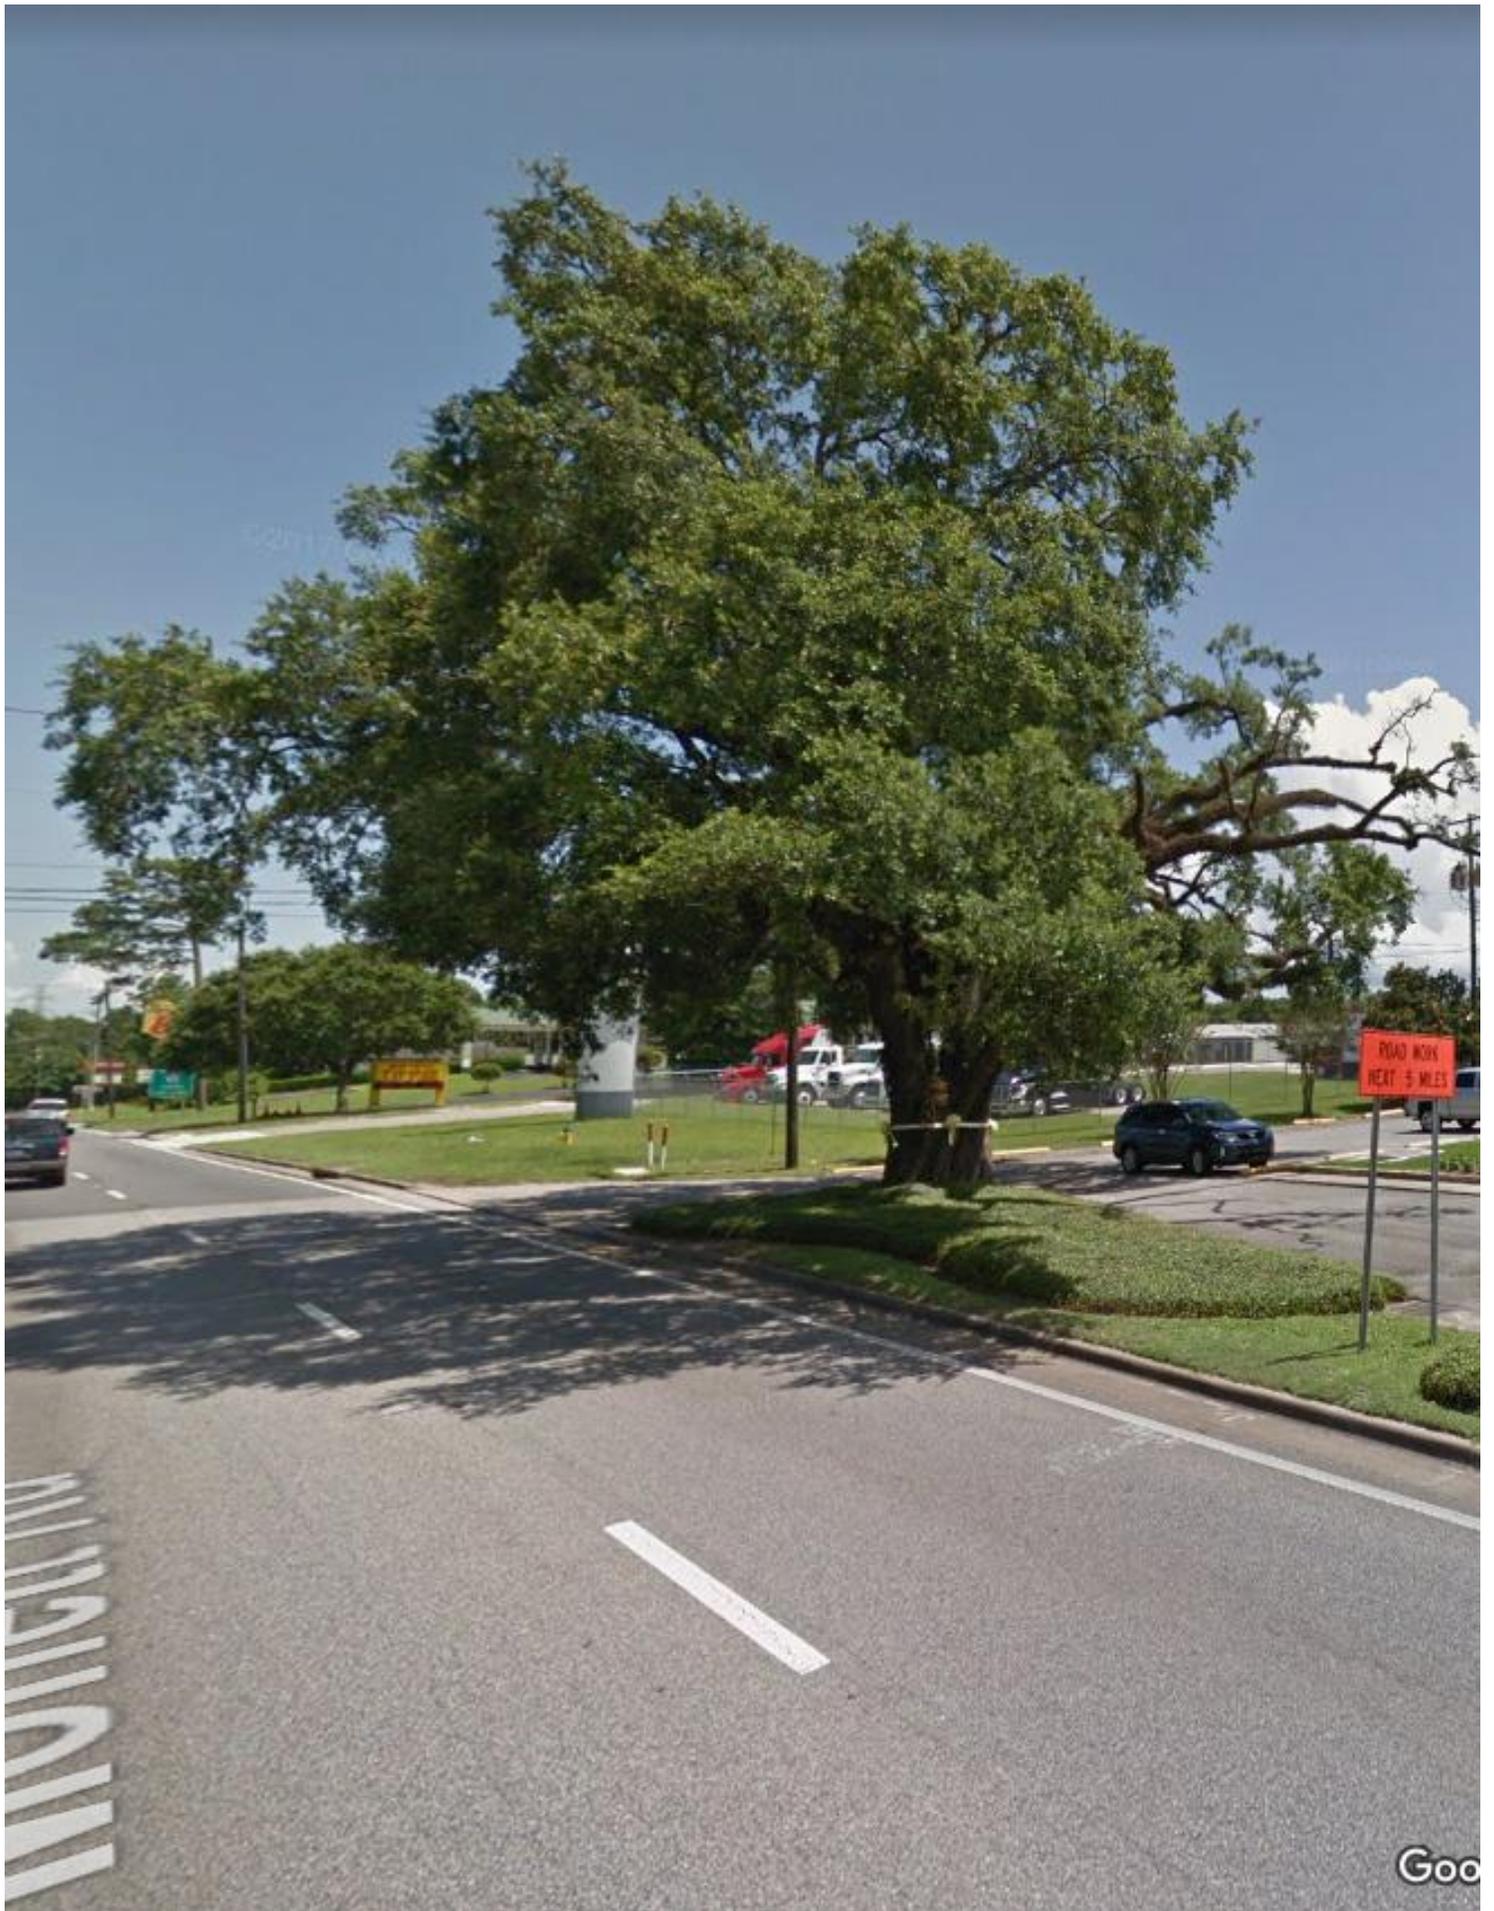
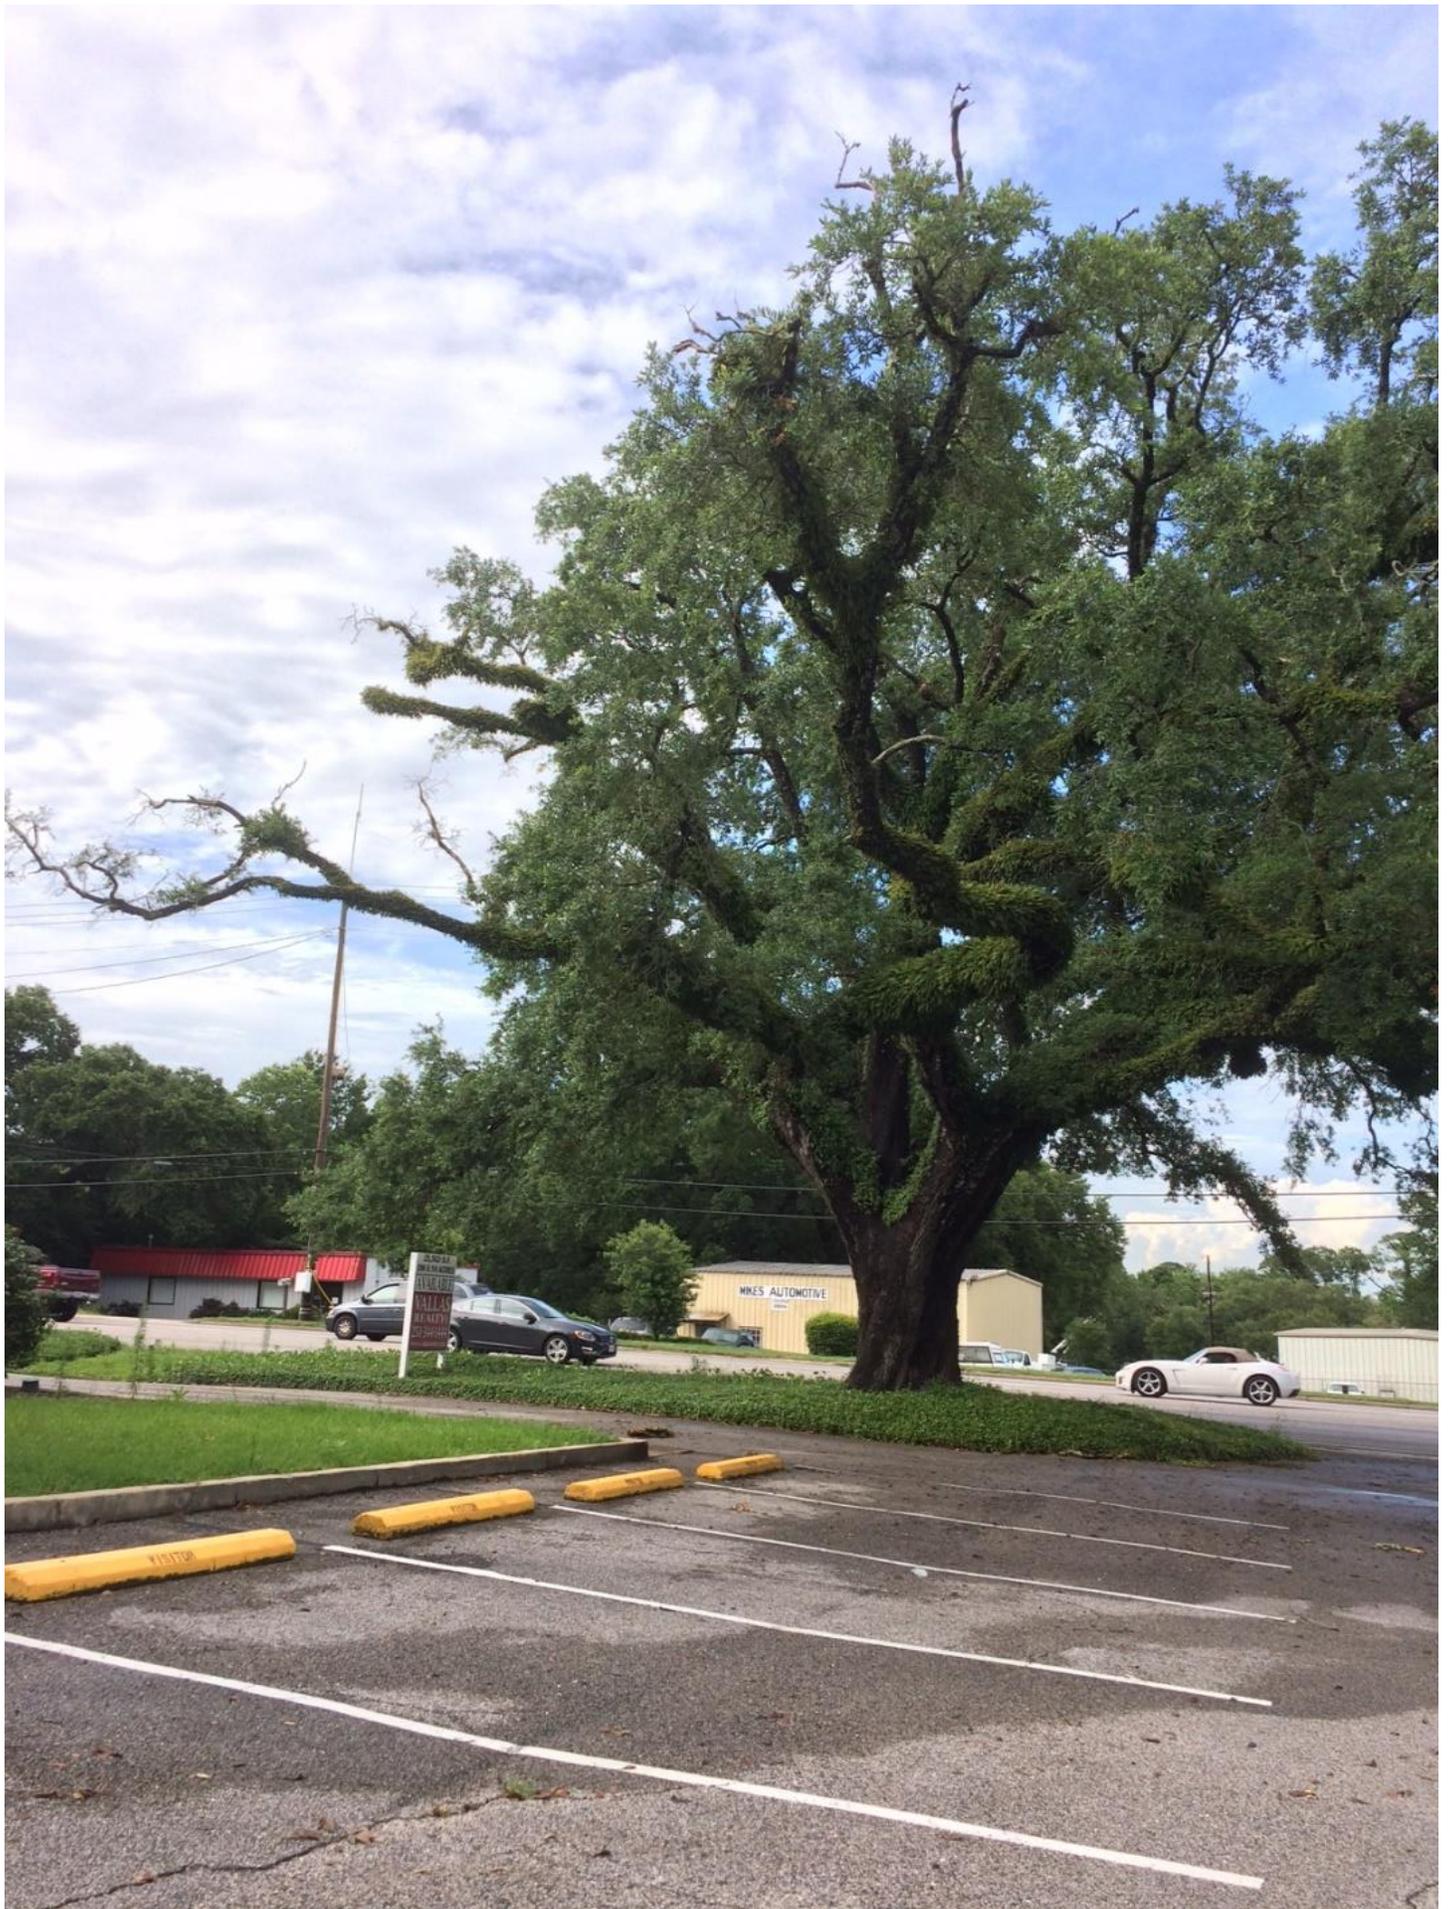
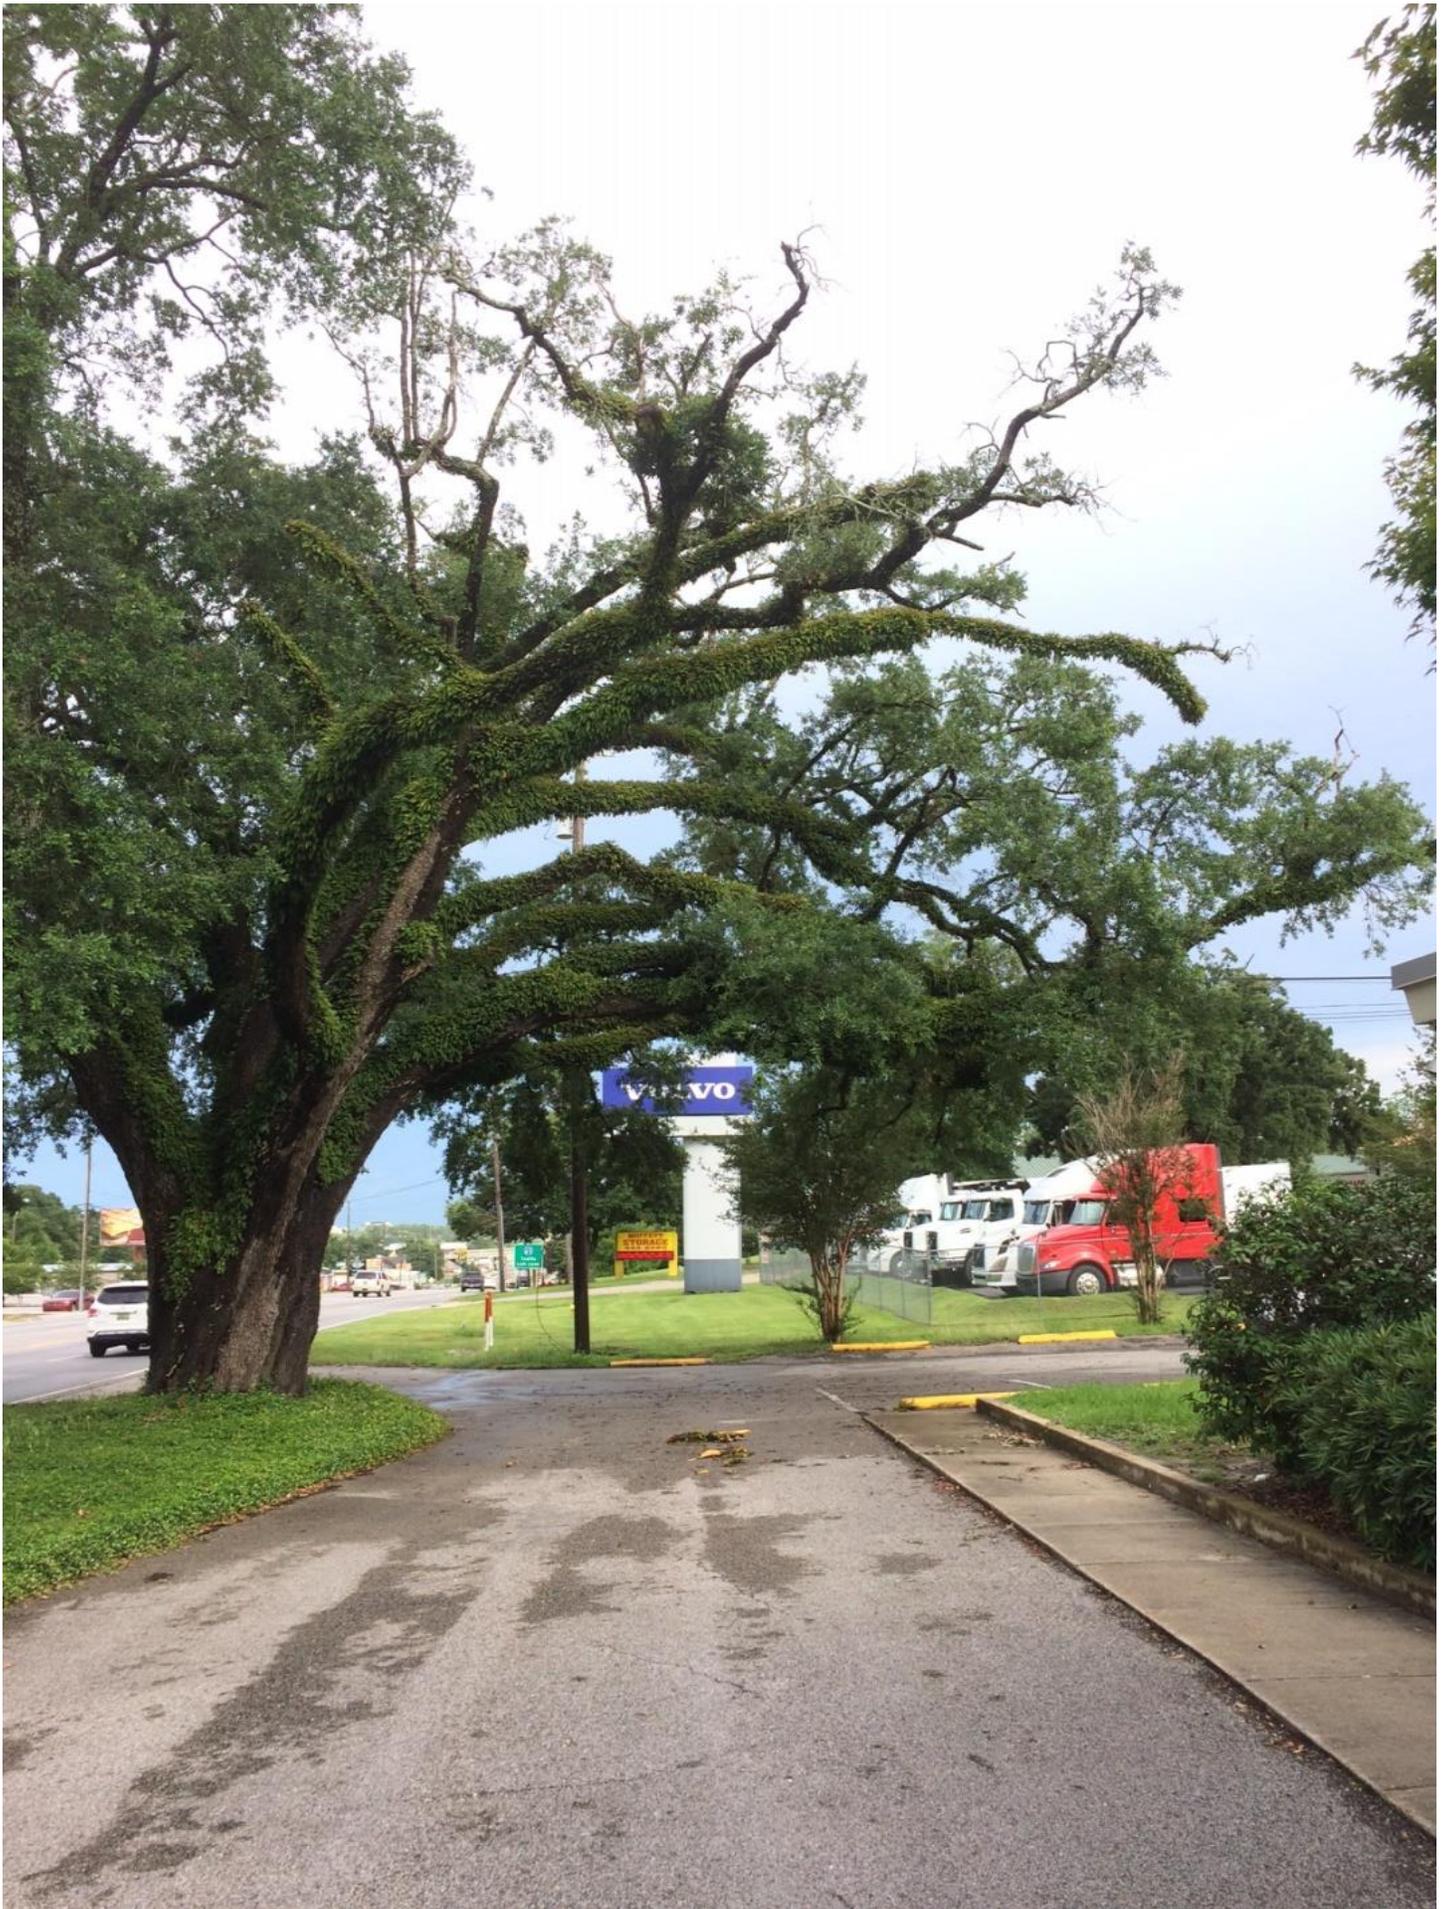
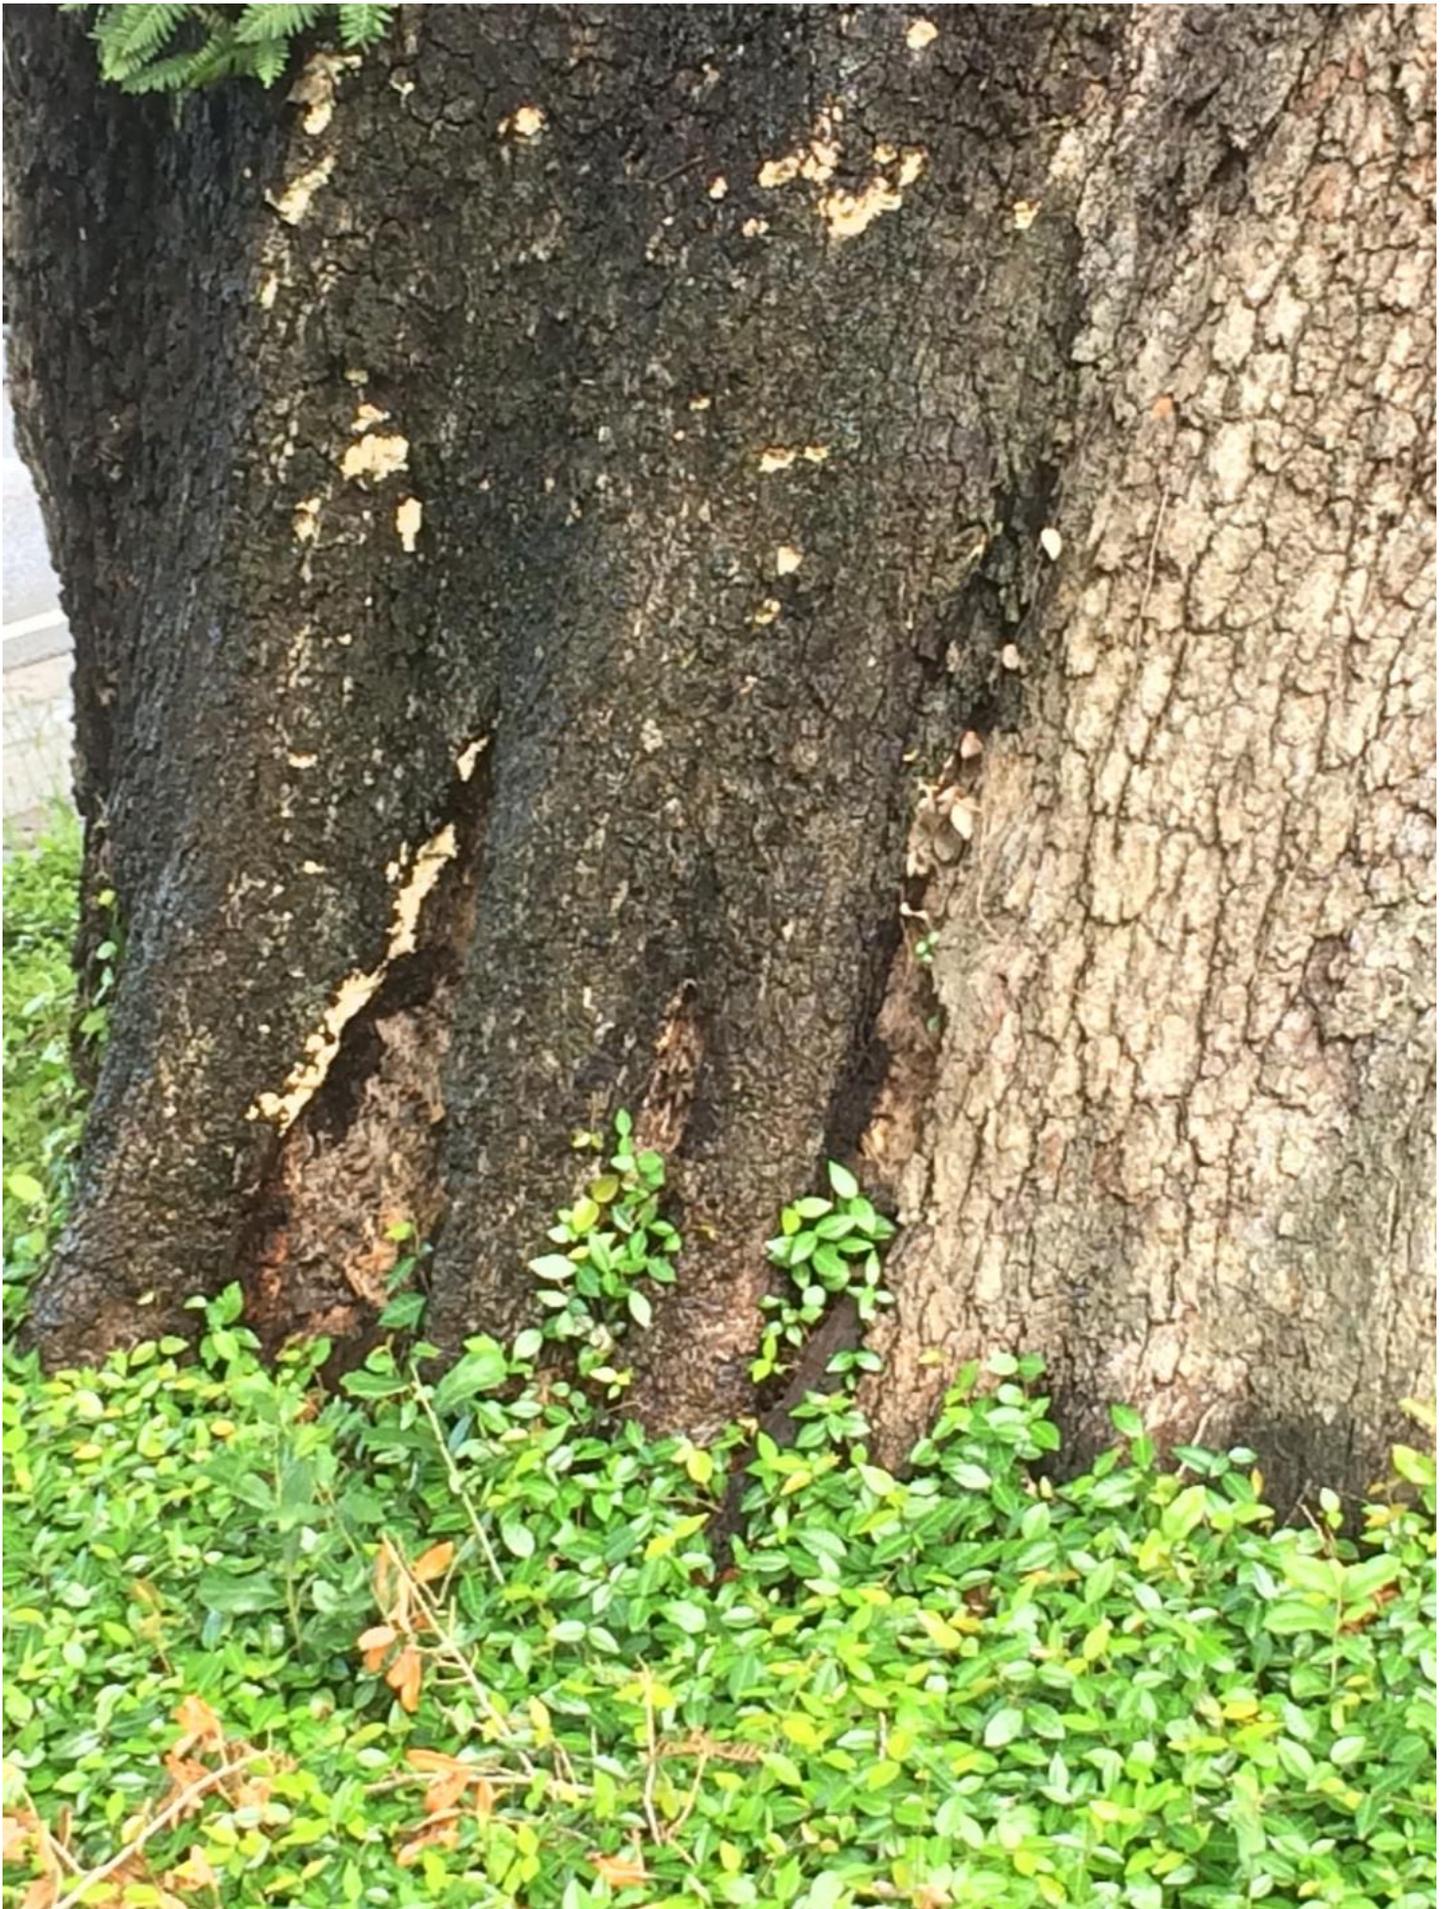
Based upon a site visit, the tree does appear to be experiencing some die-back, with between one-third and one-half of the canopy affected.

- *The overall likelihood of failure is “Probable” — The tree parts most likely to fail are the dead branches and scaffold leaders. These failures would be under normal weather conditions within this two-year time frame. This timeframe is not to be considered a “guarantee period” because weather and activities in and around the tree can have a significant impact on the overall tree’s condition and the likelihood of failure.*

- *The overall likelihood of Whole Tree Failure is “Possible —This failure would be expected in extreme weather conditions, but is unlikely during normal weather conditions within this two-year time frame.*

- *The overall likelihood of failure and impacting a target area is “Somewhat Likely” — failure of the scaffold leaders or branches could hit several of the target areas (people, parked cars, traffic).*

- *The overall likelihood of whole tree failure and impacting a target is “Somewhat Likely” — failure of the whole tree could hit several of the target areas (people, parked cars, traffic, office building).*

- *My recommendation is for removal of the Live Oak based on the characteristics of the wood decay fungus combined with the overall decline in the canopy. Both of these factors lead me to believe that the root plate has significant loss. Testing the strength of the root plate is not available or very accurate, other visual factors are taken into consideration when determining the amount of root loss. There are several visible signs throughout the canopy that leads me to believe that the root plate has lost several structural roots as described in the findings. Trees with decaying root plates are more likely to fail during significant weather conditions, as root plates are in part the structural anchor points for the tree.*

RECOMMENDATION **Based on the preceding, it is recommended that the Commission approval removal of the tree, subject to the following conditions:**
